Ian Lively
Lively Professional Services Ltd

Prepared For The Silks Galgate

26 Issues Identified

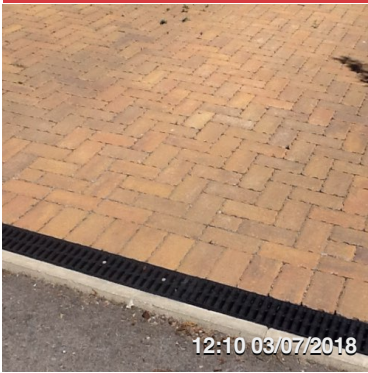
LOCATION 1 DRIVE

Block paving stones the drive have sunk in various places. Relay and level

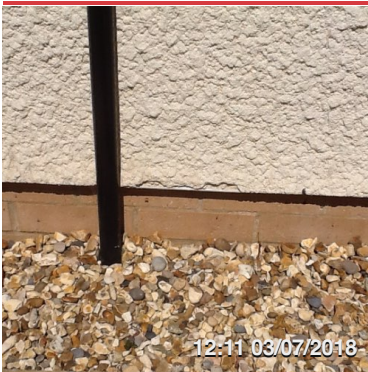
LOCATION 2 RIGHT HAND GABLE

Render has broken away below the electricity box, above the bell cast bead.

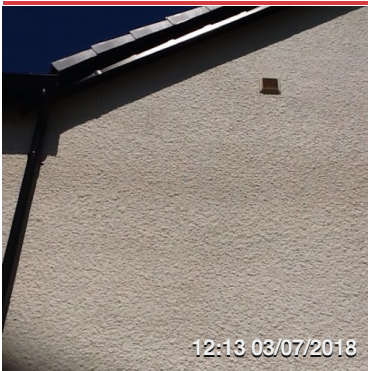
LOCATION 3 RIGHT HAND GABLE

Severe cracking to the render on the right hand gable. Take off and investigate the reason why and if necessary provide a structural engineers report.

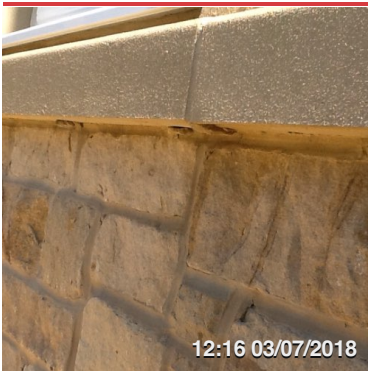
LOCATION 4 FRONT ELEVATION LOUNGE WINDOW

Remove stone packers from bellow the window chill and re point

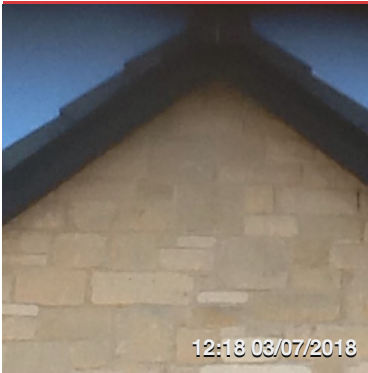
LOCATION 5 FRONT ELEVATION

Pointing to the stonework at the apex of the pike needs re pointing

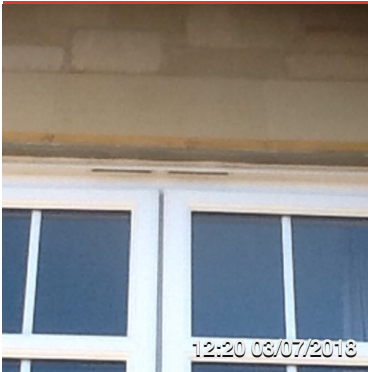
LOCATION 6 FRONT ELEVATION BEDROOM WINDOW

Remove stone packers from below the lintel and re point

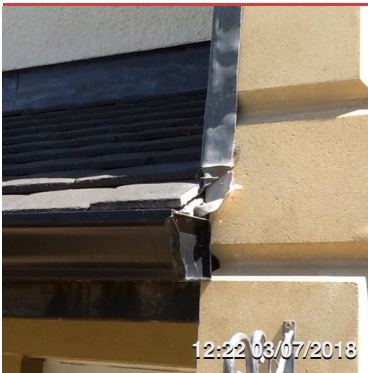
LOCATION 7 FRONT ELEVATION PORCH

Trim excessive felt from the right hand side of the low level roof and replace with lead

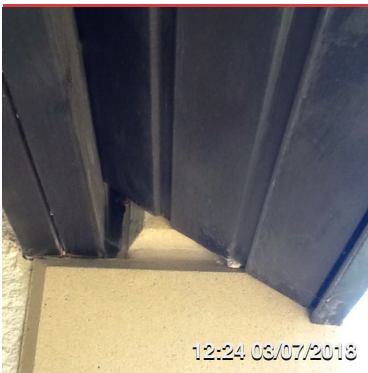
LOCATION 8 FRONT ELEVATION UNDERNEATH THE PORCH ROOF

Point gap between the perlin and stone coin to prevent ingress of wildlife

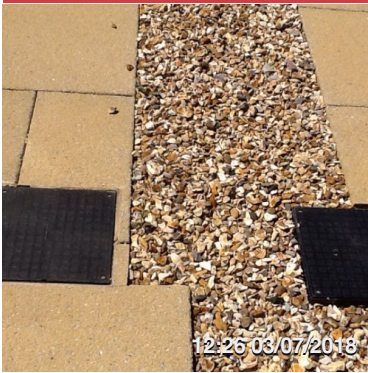
LOCATION 9 FRONT PATH

Differential between adjoining path, relay to match or replace the cut flag

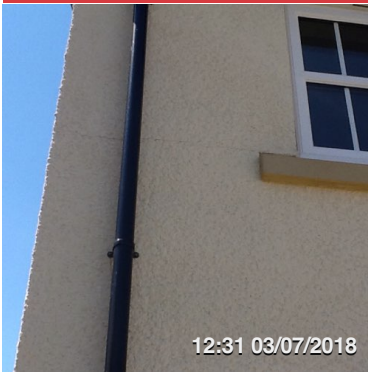
LOCATION 10 REAR ELEVATION

Severe cracking to the rear elevation, provide a Structural Engineers report and rectify.

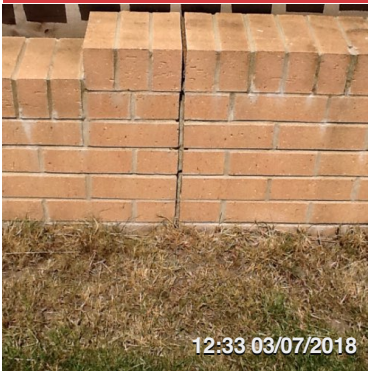
LOCATION 11 REAR GARDEN

Mastic expansion joint

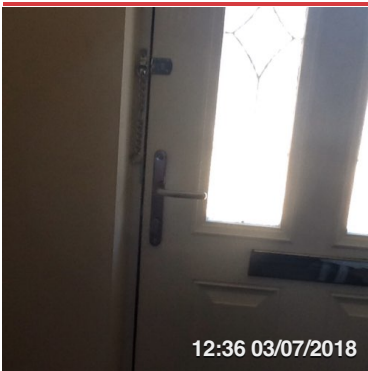
LOCATION 12 HALL

Poor fitting of the front door, re align

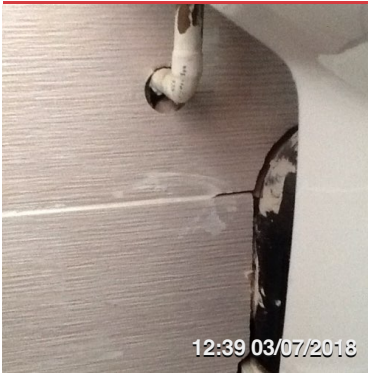
LOCATION 13 DOWNSTAIRS CLOAKROOM

Grout missing behind the toilet

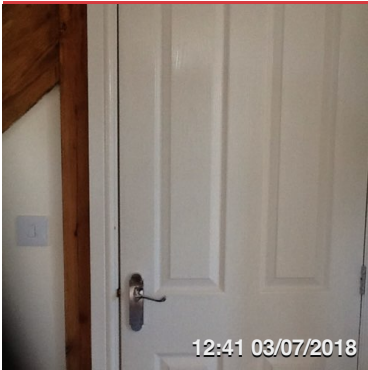
LOCATION 14 HALL UNDER STAIRS DOOR

Excessive gaps between door and the frame

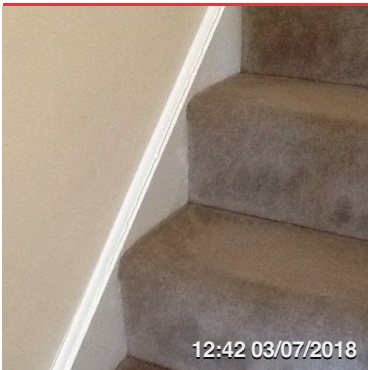
LOCATION 15 STAIRS

Shrinkage to the stairs bead, caulk and redecorate

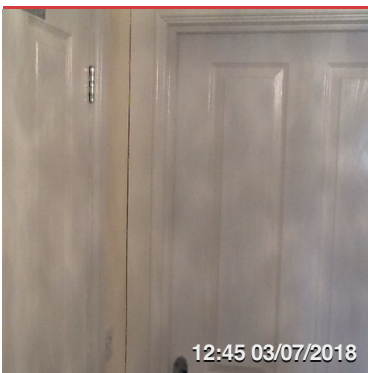
LOCATION 16 LANDING

Excessive shrinkage to the front bedroom door

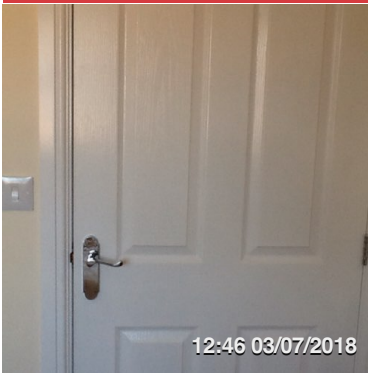
LOCATION 17 REAR BEDROOM

Excessive gap to the bedroom door

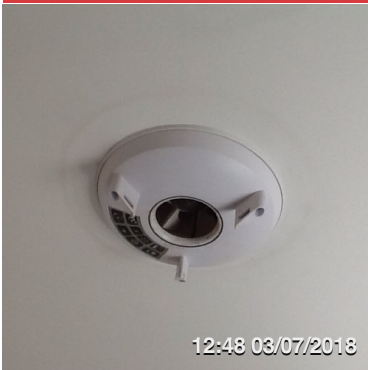
LOCATION 18 BATHROOM

Water stain around the extractor fan, check the insulation to the duct, or roof

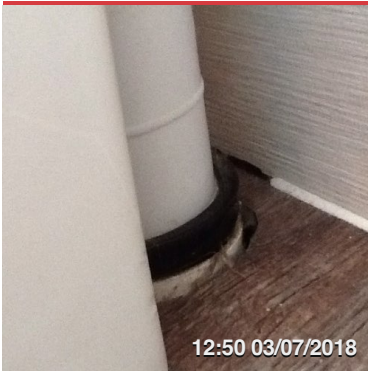
LOCATION 19 BATHROOM

Mastic missing from behind the toilet

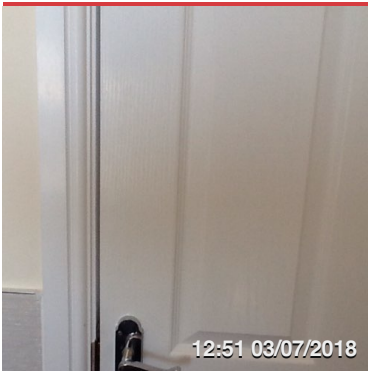
LOCATION 20 BATHROOM

Excessive gap to the bathroom door, adjust

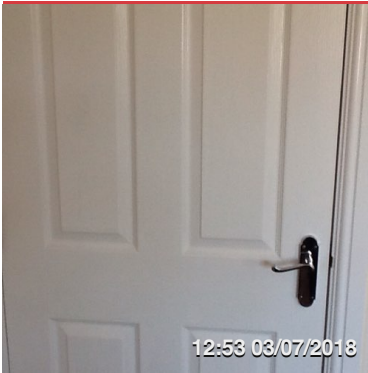
LOCATION 21 MAIN BEDROOM

Excessive gap and poorly fitted door replace and re decorate

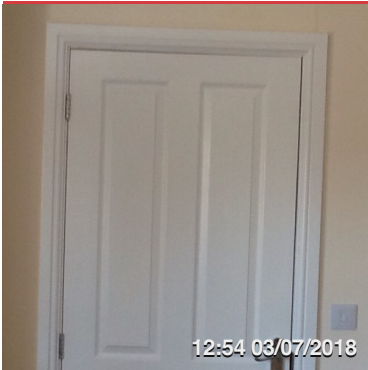
LOCATION 22 MAIN BEDROOM

Poorly fitted door and damage to the casing

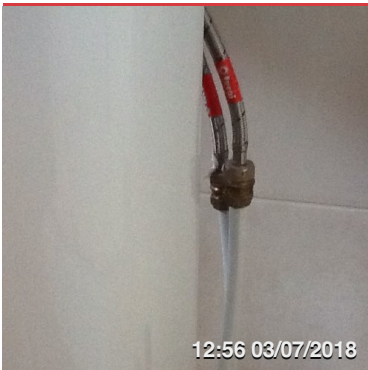
LOCATION 23 ENSUITE

Poorly fitted pipe work behind the ensuite sink, check all wet rooms

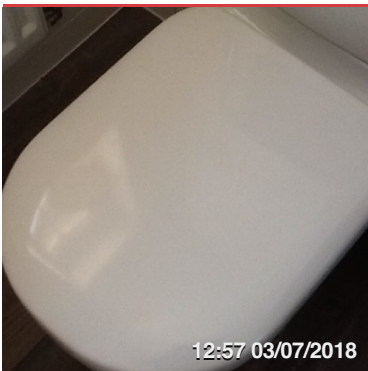
LOCATION 24 ENSUITE

Toilet seat is loose, tighten

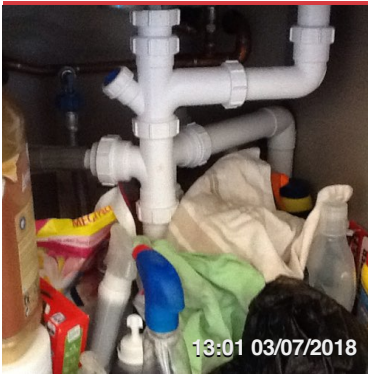
LOCATION 25 KITCHEN

Assigned To Kitchen Fitter
Sink base shelf is missing

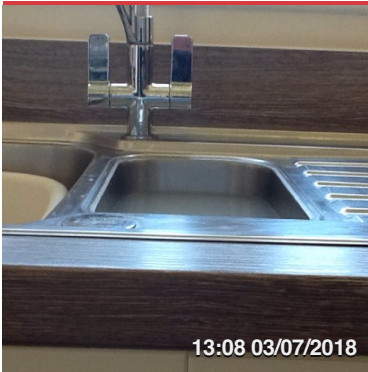
LOCATION 26 KITCHEN

Assigned To Kitchen Fitter
Kitchen sink has not been sealed and leaks
