I Lively CEnv FCIOB MCABE
Lively Professional Services Ltd

Snagging Report

Monday, 3 February 2020

LOCATION 1 -1 MARLED WALK BROMBOROUGH

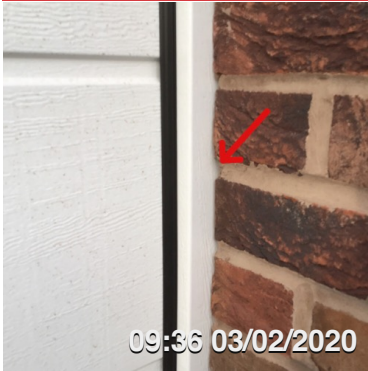
LOCATION 2 GARAGE

The garage door frame needs sealing.

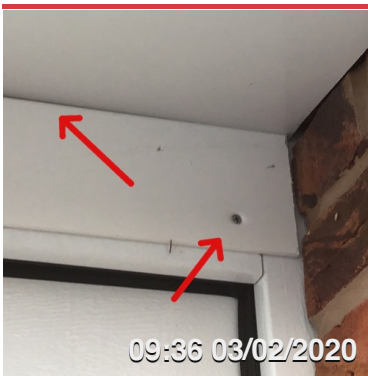
LOCATION 3 GARAGE

The screw needs a screw cap fitting and the head of the garage door needs sealing.

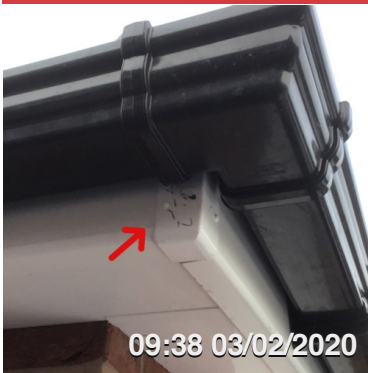
LOCATION 4 GARAGE

The left hand end cap to the fascia is damaged and needs replacing.

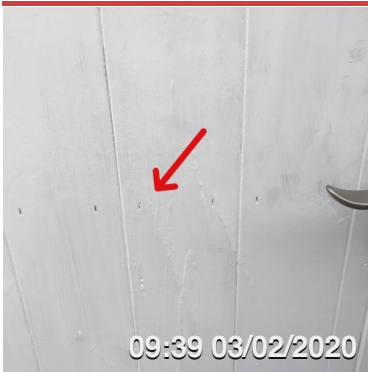
LOCATION 5 GARAGE

The garage door and frame needs filling and redecorating.

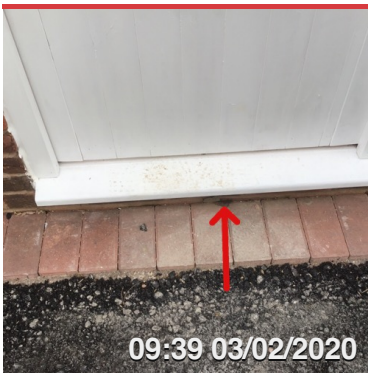
LOCATION 6 GARAGE

The underside of the garage personnel door cill needs sealing.

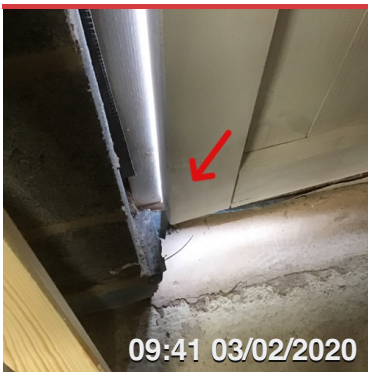
LOCATION 7 GARAGE

The garage personnel door needs easing at the bottom.

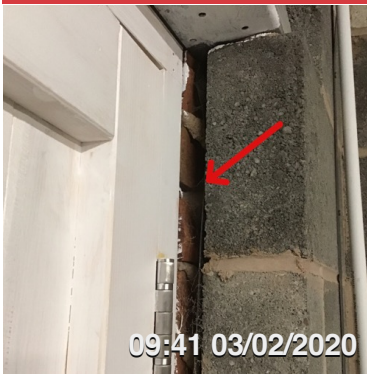
LOCATION 8 GARAGE

The gap between the blockwork and external skin needs pointing to both sides of the garage personnel door.

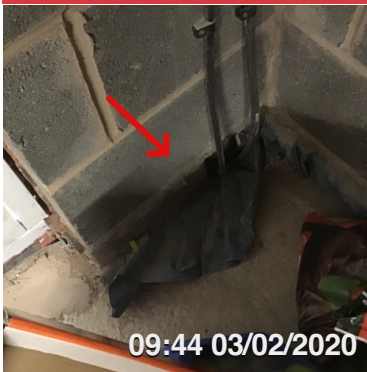
LOCATION 9 GARAGE

The Visqueen needs trimming, and the hole filling where the electric cables come into the garage.

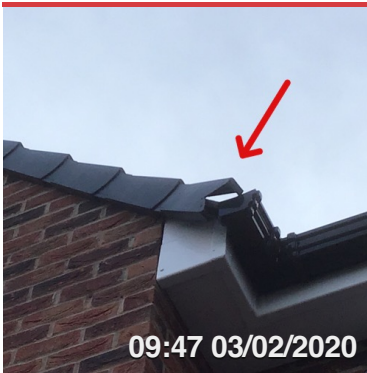
LOCATION 10 FRONT ELEVATION

The bottom dry verge needs refixing were the gutter has pushed it out, make sure all bottom dry verge are mechanically fixed.

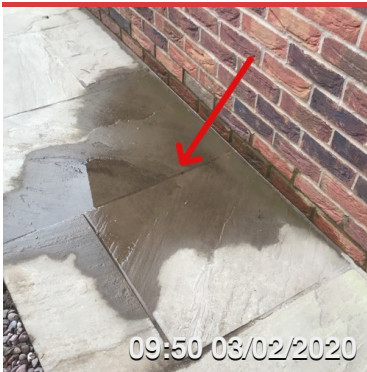
LOCATION 11 LEFT HAND ELEVATION

There are areas of flagging that are holding water, which needs rectifying. (NHBC 9.1.15 External Works)

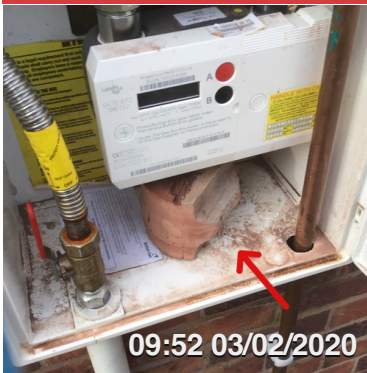
LOCATION 12 LEFT HAND ELEVATION

The boiler flue core needs removing from the gas box.

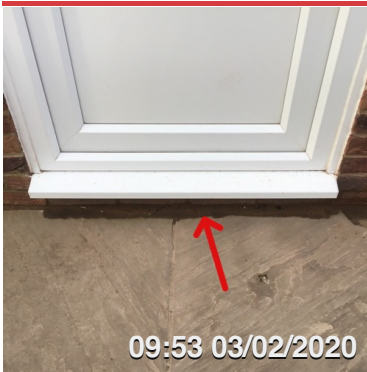
LOCATION 13 LEFT HAND ELEVATION

The utility door needs sealing underneath.

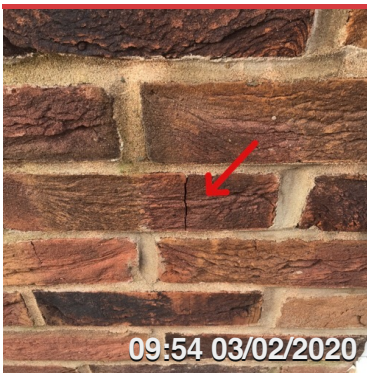
LOCATION 14 LEFT HAND ELEVATION

The 5th brick up from the damp course is split and needs replacing, there are no others visible with a full split in the brick.

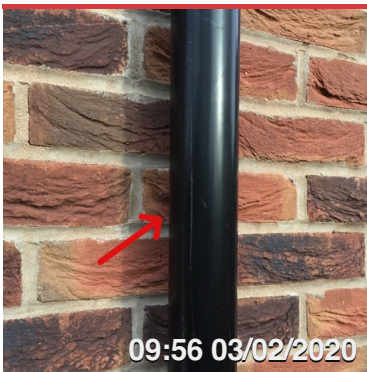
LOCATION 15 REAR ELEVATION

The right hand downspout is badly scratched.

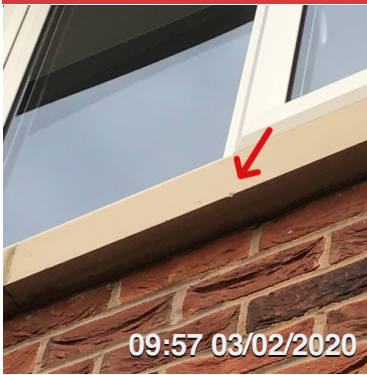
LOCATION 16 REAR ELEVATION

The right hand bedroom window cill is chipped in several places and needs repairing or replacing.

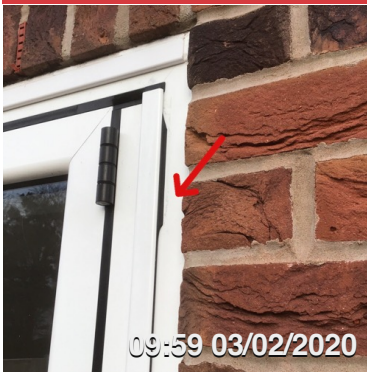
LOCATION 17 REAR ELEVATION

The right hand seal on the bifold doors needs easing out.

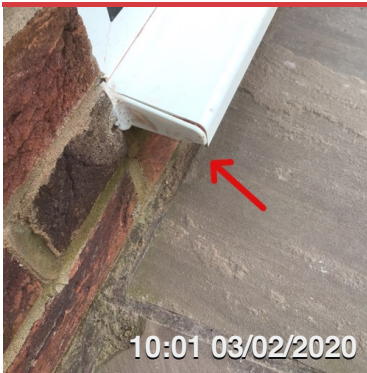
LOCATION 18 REAR ELEVATION

The left hand cill cap is damaged and needs replacing.

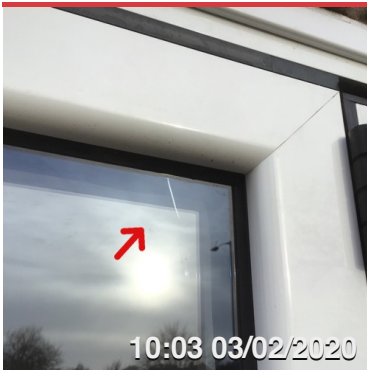
LOCATION 19 REAR ELEVATION

The right hand bifold door glass is marked on the inside.

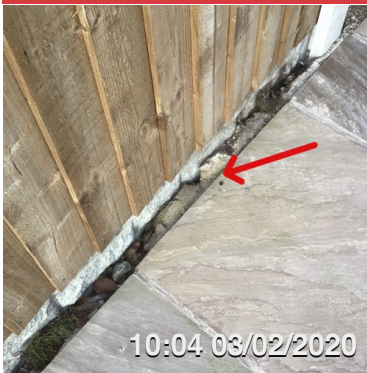
LOCATION 20 REAR ELEVATION

The end of the flags needs finishing.

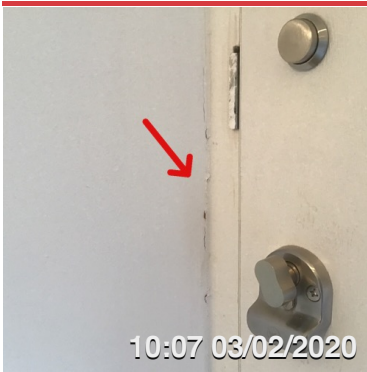
LOCATION 21 HALL

The front door frame needs re caulking.

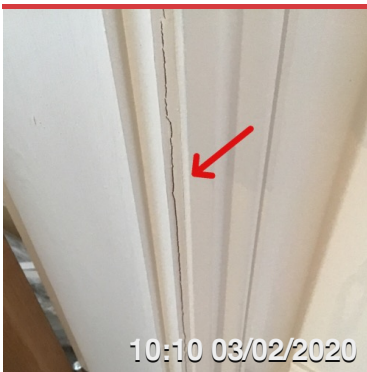
LOCATION 23 HALL

The study door architrave needs caulking.

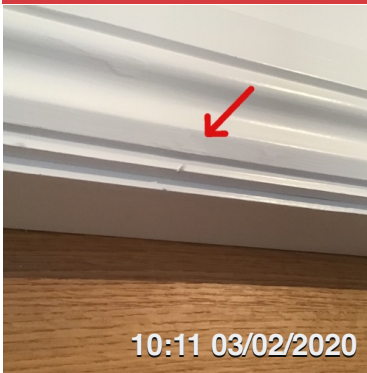
LOCATION 24 HALL

The lounge casing needs filling.

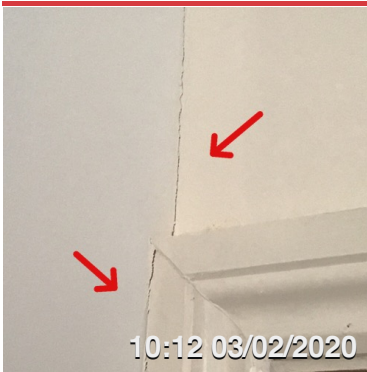
LOCATION 25 HALL

The architrave and wall above the understairs cupboard needs caulking.

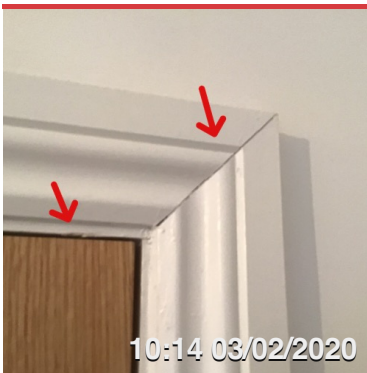
LOCATION 26 HALL

The architrave and casing to the downstairs cloakroom needs caulking and filling.

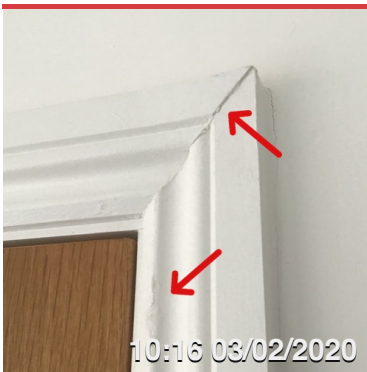
LOCATION 27 STUDY

The right hand architrave is lipping and needs sanding, it also needs sanding.

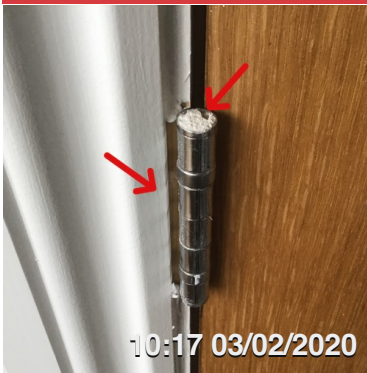
LOCATION 28 STUDY

The paint needs removing from the hinges and the bare timber needs painting and caulking behind them.

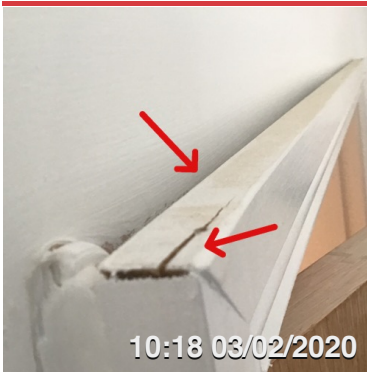
LOCATION 29 STUDY

The gap at the top of the architrave needs filling and the split where it has been pinned together.

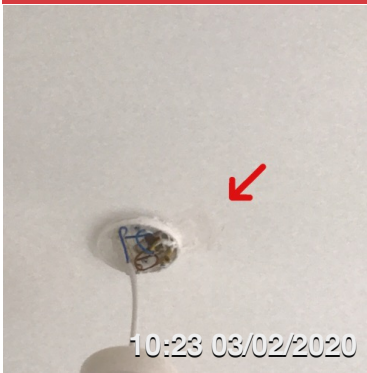
LOCATION 32 STUDY

The ceiling rose needs fitting and the ceiling sanding and touching up.

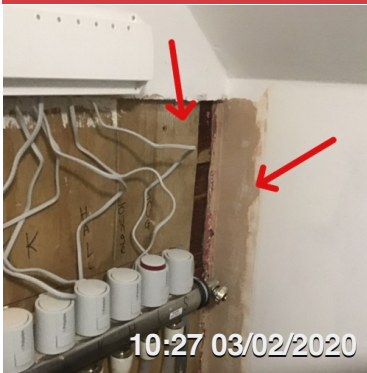
LOCATION 36 UNDERSTAIRS CUPBOARD

The wall and timber need filling and painting.

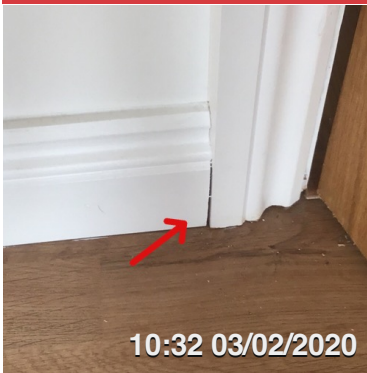
LOCATION 40 KITCHEN

The skirting board needs caulking behind the door.

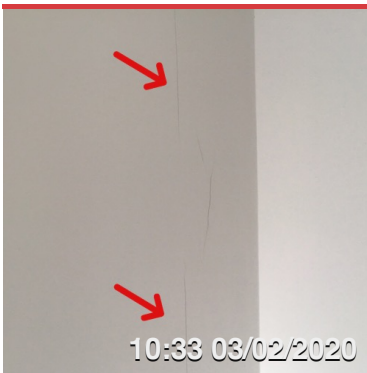
LOCATION 42 KITCHEN

The cracking in the wall needs filling.

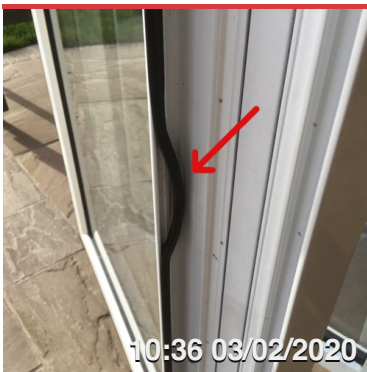
LOCATION 43 KITCHEN

The seal on the bifold door frame needs refitting.

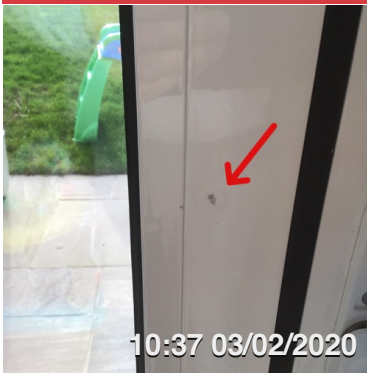
LOCATION 44 KITCHEN

The bifold door frame is dented in the left and right hand end units.

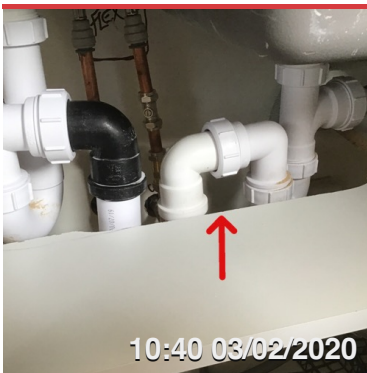
LOCATION 46 KITCHEN

The sink base shelf needs sealing with silicone to prevent it from blowing if the trap leaks.

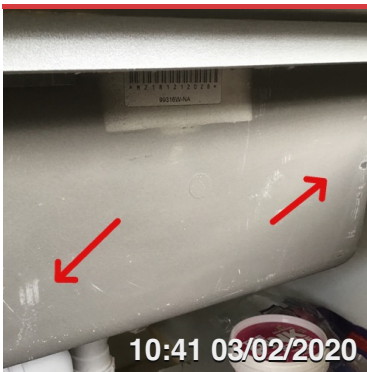
LOCATION 47 KITCHEN

The sink is badly marked on the outside of the bowl.

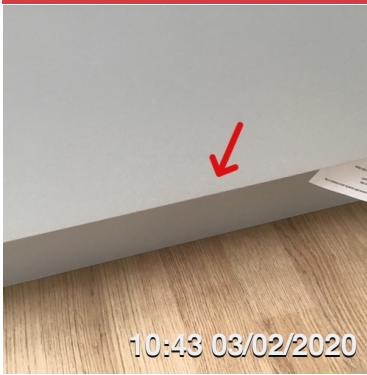
LOCATION 48 KITCHEN

The bottom drawer has a chip on the bottom.

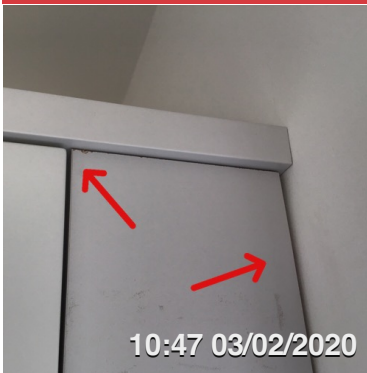
LOCATION 52 KITCHEN

The right hand infill is chipped and needs caulking against the wall.

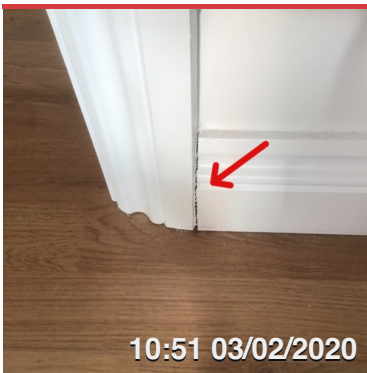
LOCATION 54 KITCHEN

The skirting board needs caulking to the utility door.

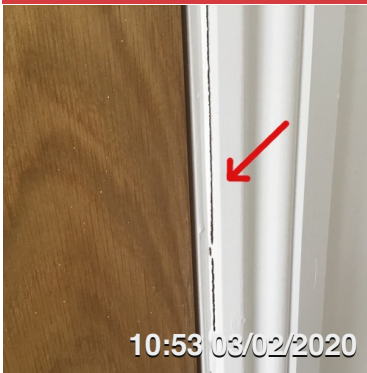
LOCATION 56 UTILITY

The architrave needs caulking behind the door.

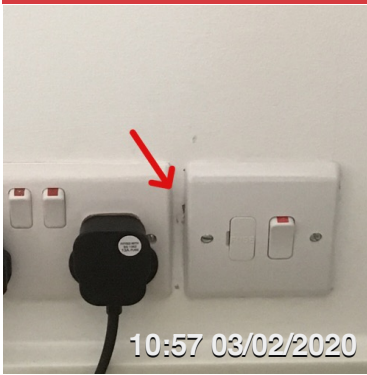
LOCATION 60 UTILITY

The wall needs touching up between the sockets.

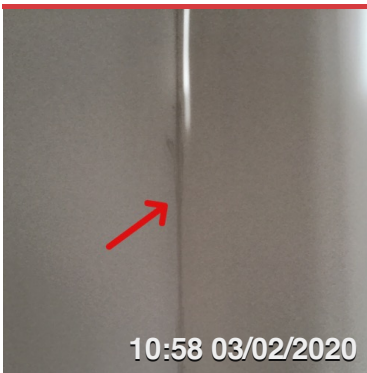
LOCATION 62 UTILITY

The corner of the wall needs touching up.

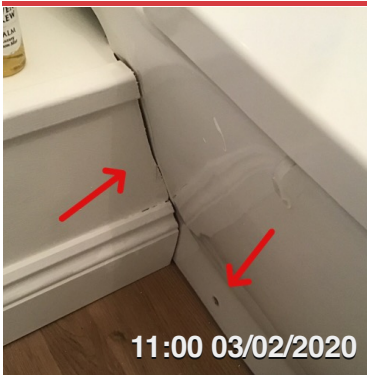
LOCATION 64 DOWNSTAIRS CLOAKS

The boxing needs sealing and the caps need fitting in the toilet pan.

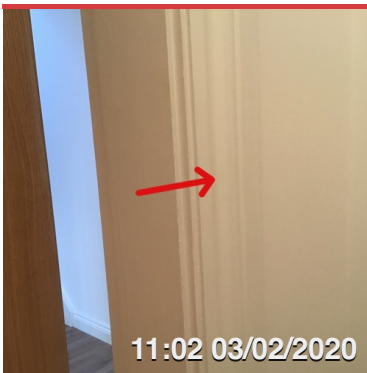
LOCATION 66 DOWNSTAIRS CLOAKS

The right hand architrave needs caulking.

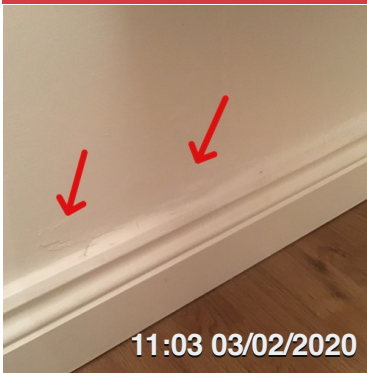
LOCATION 68 DOWNSTAIRS CLOAKS

The wall underneath the vanity unit needs sanding.

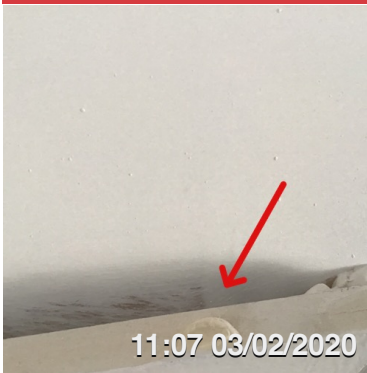
LOCATION 72 LOUNGE

The gap between the architrave and wall needs filling.

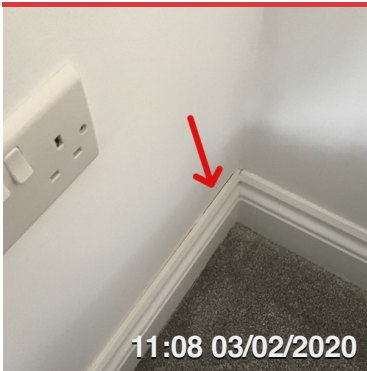
LOCATION 74 LOUNGE

The top of the skirting board in the right hand corner needs caulking.

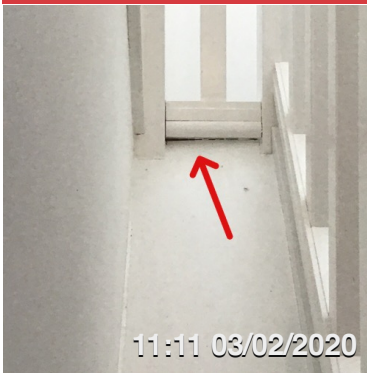
LOCATION 76 STAIRS TO FIRST FLOOR

The top of the infill between the stairs and wall needs a bead fitting.

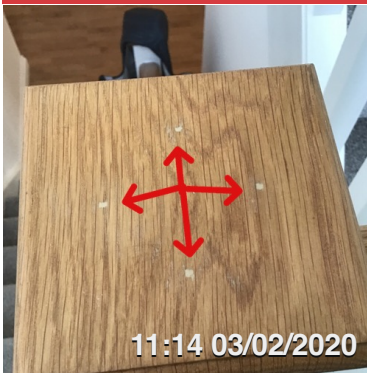
LOCATION 80 STAIRS TO FIRST FLOOR

The filler needs staining the same as the newel caps on the stairs.

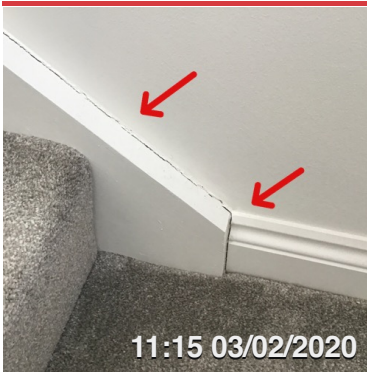
LOCATION 81 STAIRS TO FIRST FLOOR

The string and skirting board needs caulking, it may be advantageous to fit a quadrant on top of the string.

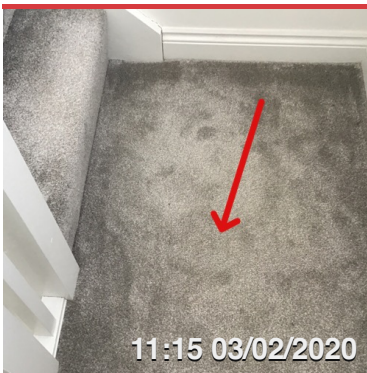
LOCATION 82 STAIRS TO FIRST FLOOR

The floor boarding on the first landing is loose and needs refixing.

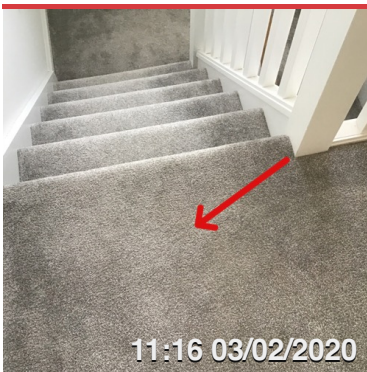
LOCATION 83 LANDING

The floor is squeaking at the top of the stairs and needs fixing.

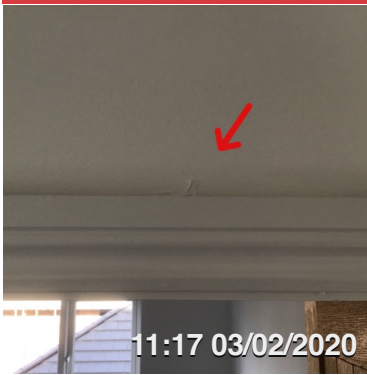
LOCATION 84 LANDING

The wall needs sanding above bedroom 3.

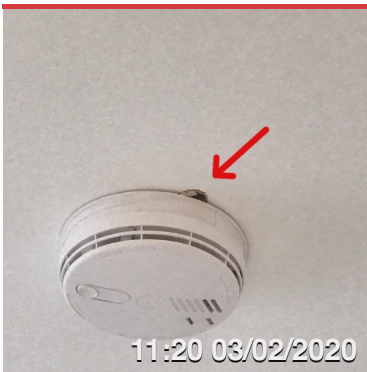
LOCATION 87 LANDING

The ceiling needs filling next to the smoke alarm.

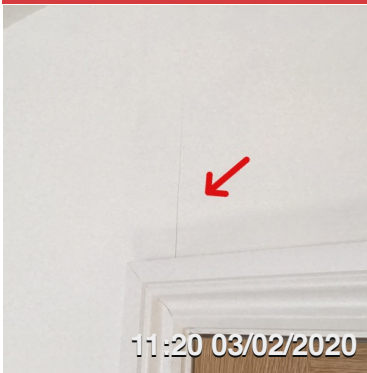
LOCATION 88 LANDING

The wall needs filling above the architrave to the cylinder cupboard.

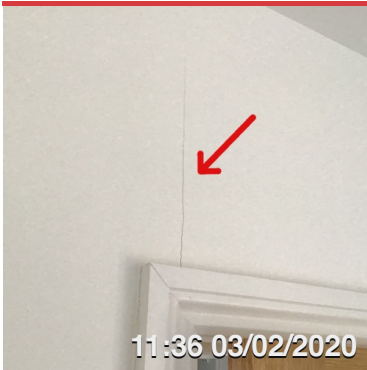
LOCATION 94 BEDROOM 1

The crack over the wardrobe door needs filling.

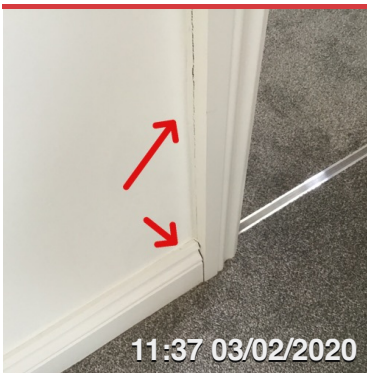
LOCATION 95 BEDROOM 1

The architrave and skirting board needs caulking to the wardrobe door.

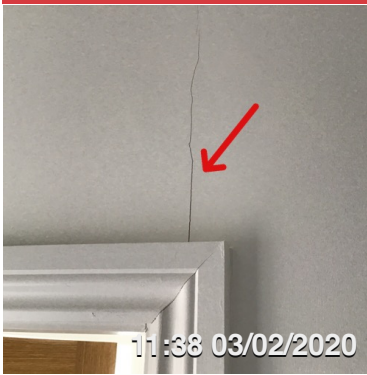
LOCATION 96 BEDROOM 1 WARDROBE

The crack over the door needs filling.

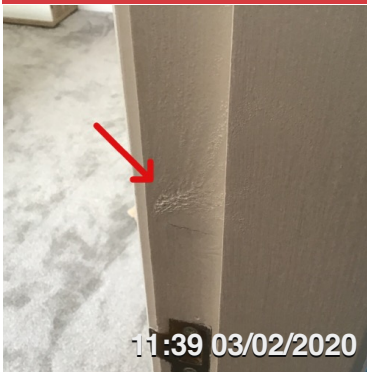
LOCATION 97 BEDROOM 1 WARDROBE

The casing needs sanding above the keeper.

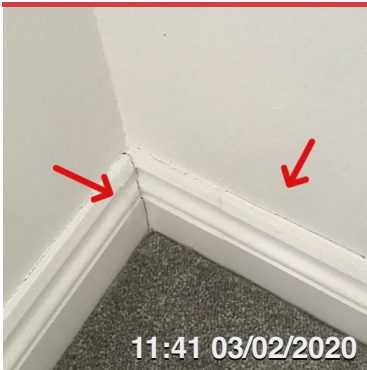
LOCATION 99 BEDROOM 1

The skirting board corners need caulking.

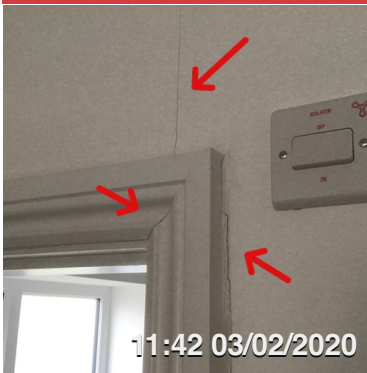
LOCATION 100 BEDROOM 1

The wall and architrave to the en-suite door needs filling.

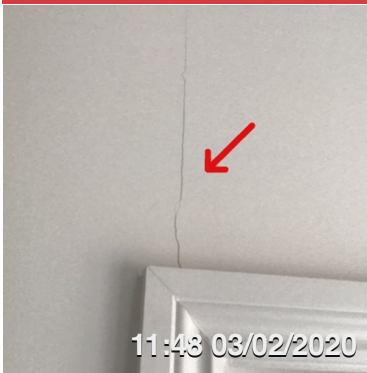
LOCATION 108 EN SUITE

The crack over the en suite door needs filling.

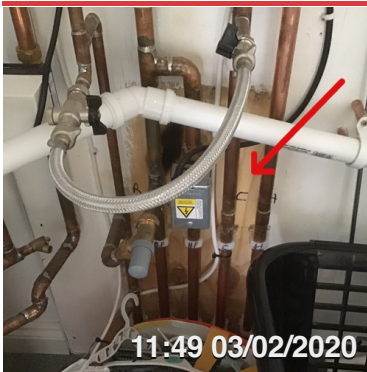
LOCATION 109 CYLINDER CUPBOARD

The timber behind the pipes needs painting.

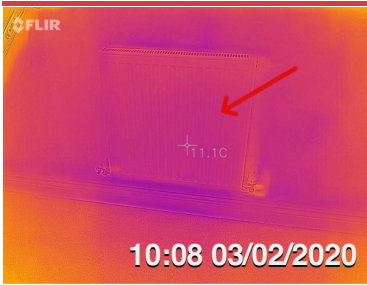
LOCATION 112 BEDROOM 2

The radiator is not heating up and could need balancing or bleeding.

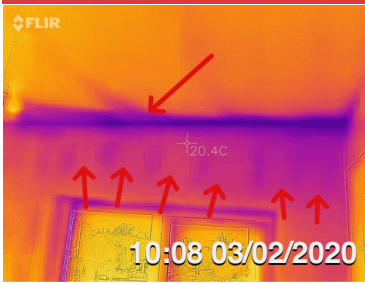
LOCATION 116 BEDROOM 4

There appears to be insulation missing over the wall plate causing cold bridging and there is no solid ribbon of adhesive behind the plaster boards.

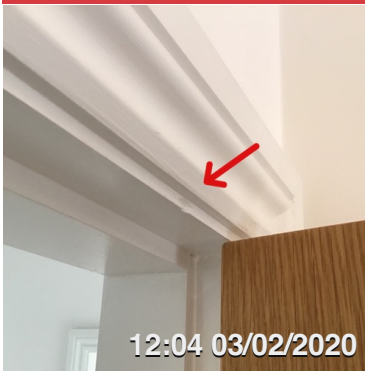
LOCATION 117 BATHROOM

The bathroom casing needs filling.

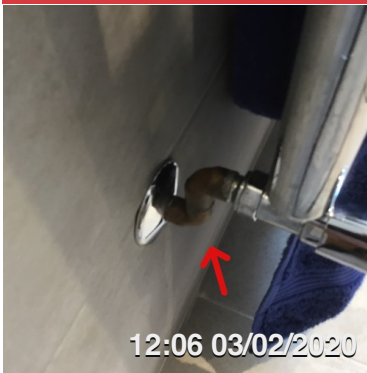
LOCATION 120 BATHROOM

The radiator pipes need painting..

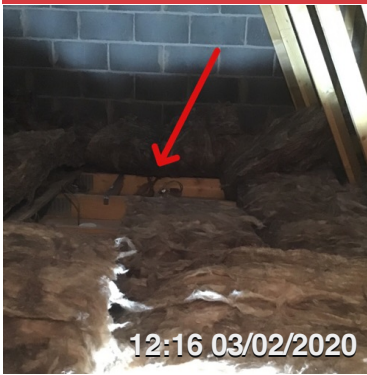
LOCATION 124 LOFT

The loft insulation is missing.

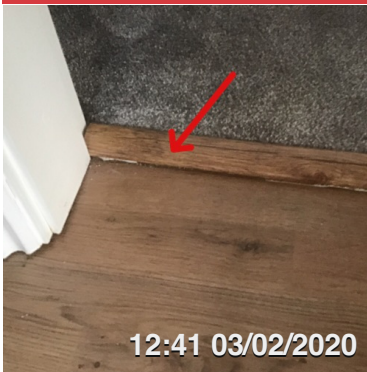
LOCATION 125 LOUNGE

The cover strip is loose over the carpet and laminate flooring.
