I Lively CEnv FCIOB MCABE
Lively Professional Services Ltd

Snagging Report

Monday, 3 February 2020

LOCATION 1 -1 MARLED WALK BROMBOROUGH

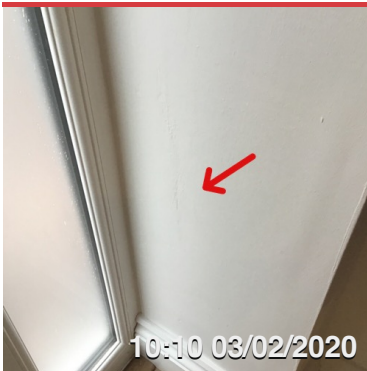
LOCATION 22 HALL

The right hand front door reveal needs filling.

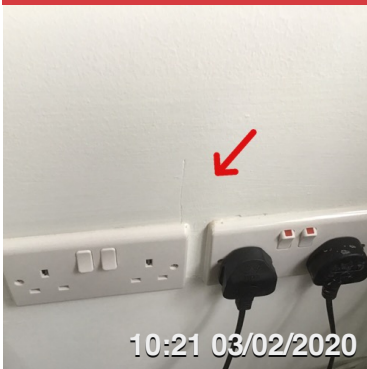
LOCATION 30 STUDY

The wall needs filling above the sockets.

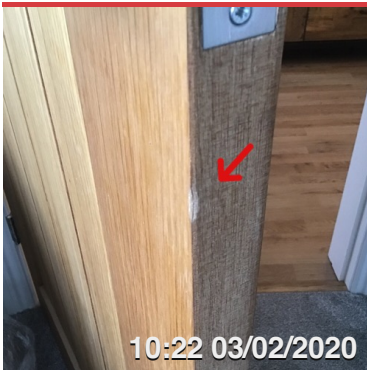
LOCATION 31 STUDY

The edge of the door is damaged.

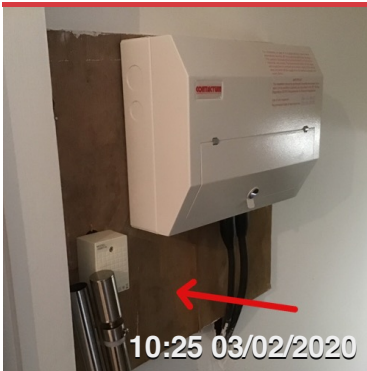
LOCATION 34 UNDERSTAIRS CUPBOARD

The timber behind the consumer unit needs painting.

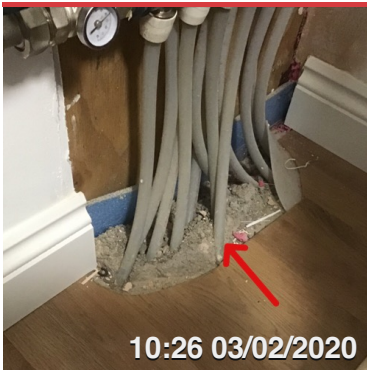
LOCATION 35 UNDERSTAIRS CUPBOARD

The finish around the under floor heating pipe work needs tidying up or boxing in.

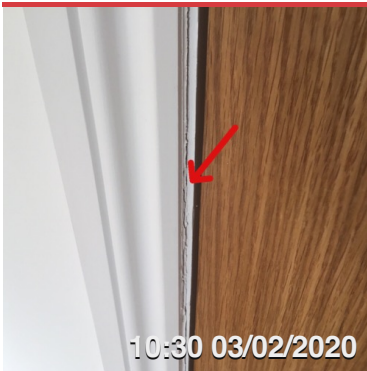
LOCATION 38 KITCHEN

The left hand architrave needs caulking.

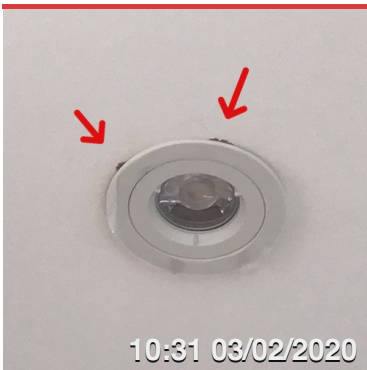
LOCATION 39 KITCHEN

The ceiling needs filling around the down light as you walk in to the kitchen.

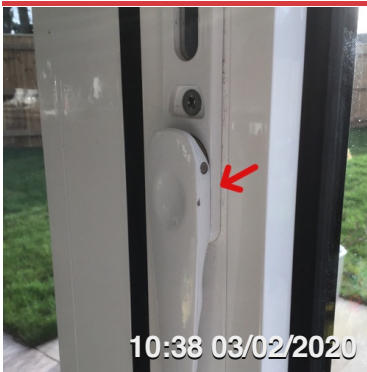
LOCATION 45 KITCHEN

The left hand handle to the bifold door is chipped.

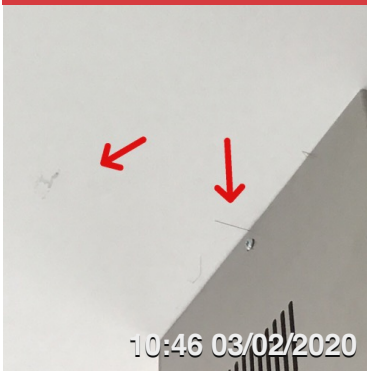
LOCATION 50 KITCHEN

The ceiling needs painting around the extractor chimney.

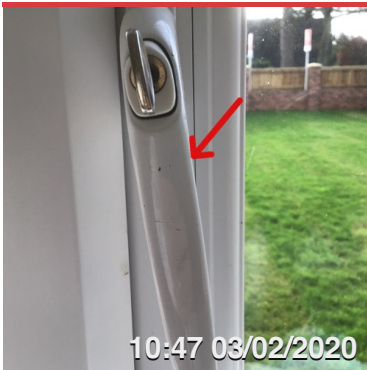
LOCATION 51 KITCHEN

The right hand window handle is damaged.

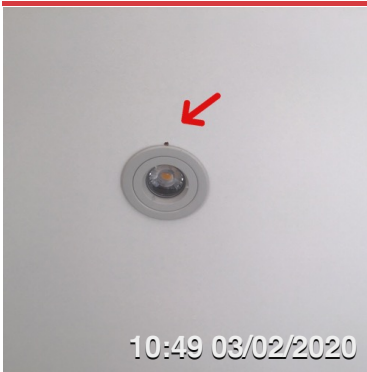
LOCATION 53 KITCHEN

The ceiling needs filling around the down light next to the window, please check all other down lights.

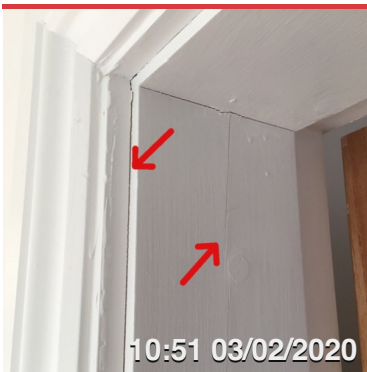
LOCATION 55 KITCHEN

The utility door casing needs filling and the architraves caulked.

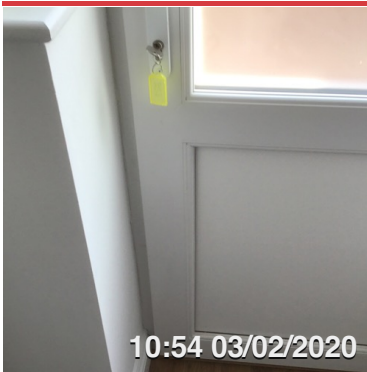
LOCATION 57 UTILITY

The utility door needs adjusting as it is catching the frame.

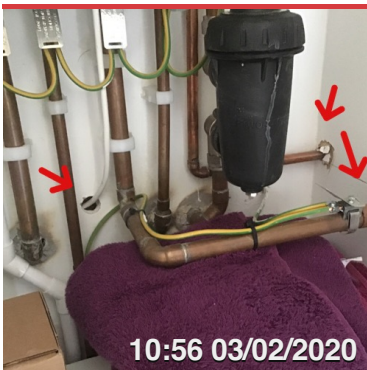
LOCATION 59 UTILITY

The holes need patching and the redecorating in the boiler housing.

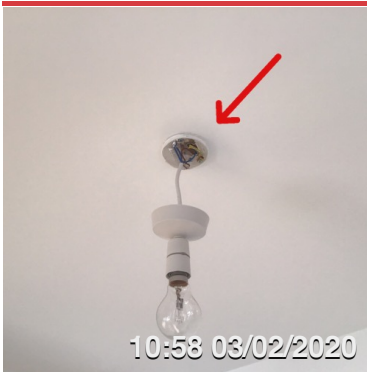
LOCATION 61 UTILITY

The ceiling rose needs refitting.

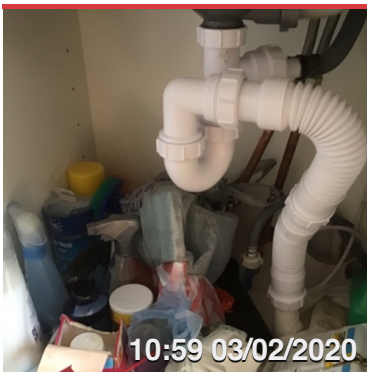
LOCATION 63 UTILITY

The sink base unit needs a shelf fitting.

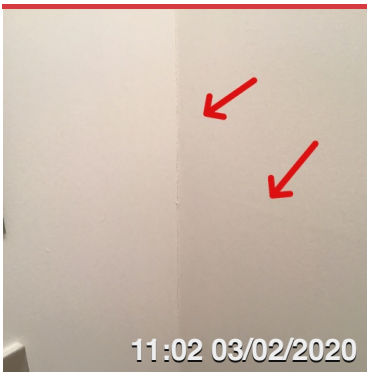
LOCATION 67 DOWNSTAIRS CLOAKS

The board joint needs sanding and the corner has cracked and needs filling.

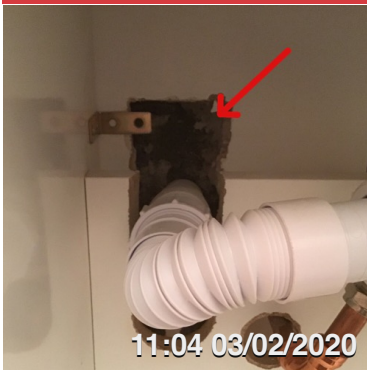
LOCATION 69 DOWNSTAIRS CLOAKS

The hole in the vanity unit needs patching.

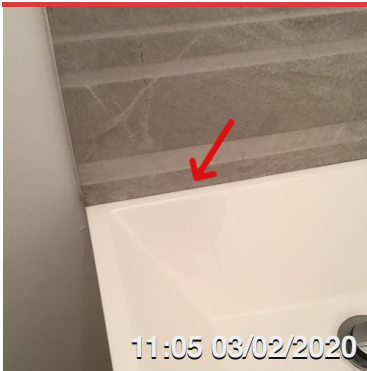
LOCATION 70 DOWNSTAIRS CLOAKS

The sink and tiles need sealing.

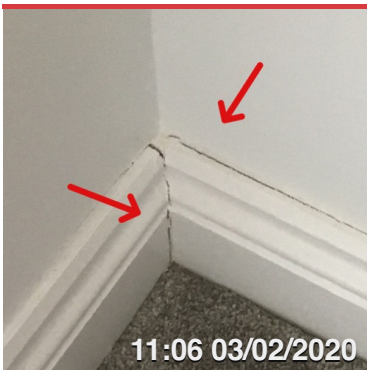
LOCATION 71 LOUNGE

The skirting board needs caulking behind the door.

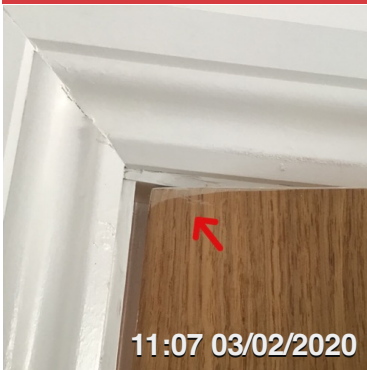
LOCATION 73 LOUNGE

The top of the door needs staining.

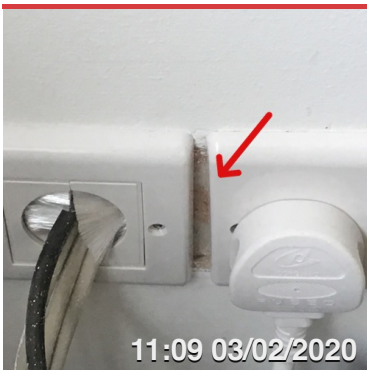
LOCATION 75 LOUNGE

The wall between the sockets needs painting.

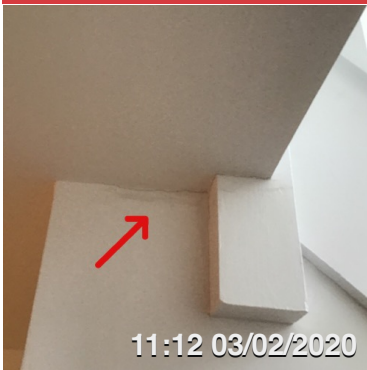
LOCATION 77 STAIRS TO FIRST FLOOR

The wall needs touching up around the newel.

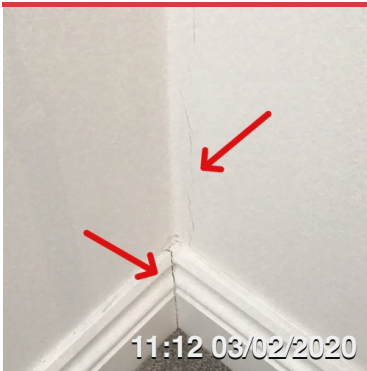
LOCATION 78 STAIRS TO FIRST FLOOR

The wall and skirting board needs filling.

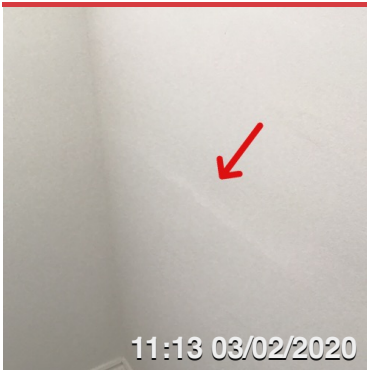
LOCATION 79 STAIRS TO FIRST FLOOR

The hollow in the wall needs filling on the half landing.

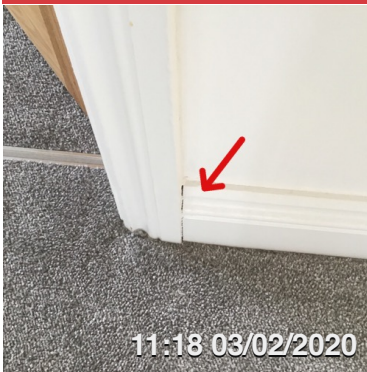
LOCATION 85 LANDING

The skirting boards need caulking to bedroom 1.

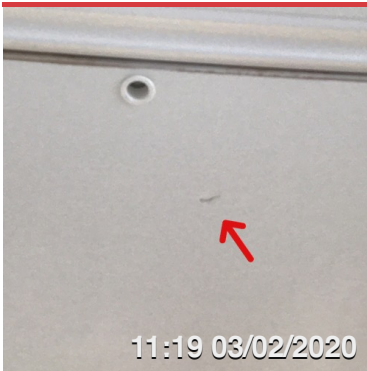
LOCATION 86 LANDING

The loft trap door is damaged and needs replacing.

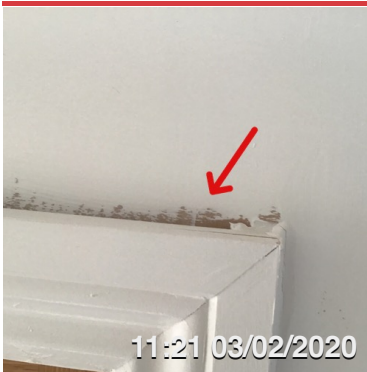
LOCATION 89 LANDING

The wall needs painting over the bathroom door.

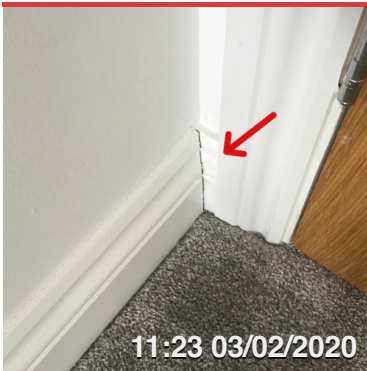
LOCATION 90 BEDROOM 3

The skirting boards needs caulking in the corners.

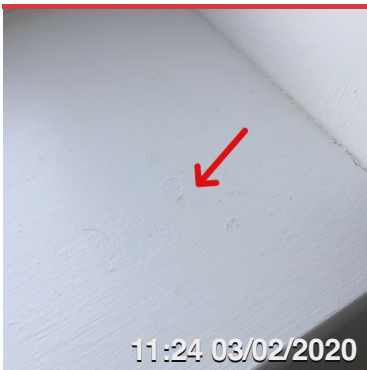
LOCATION 91 BEDROOM 3

The window cill needs filling and redecorating..

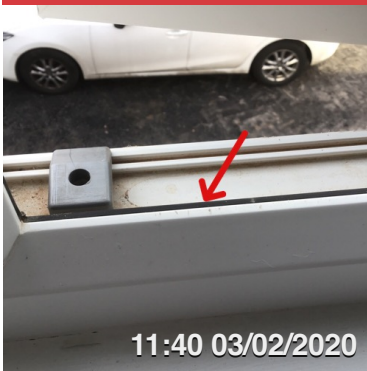
LOCATION 98 BEDROOM 1

The top of the right hand sash frame is damaged where materials have been brought in through it.

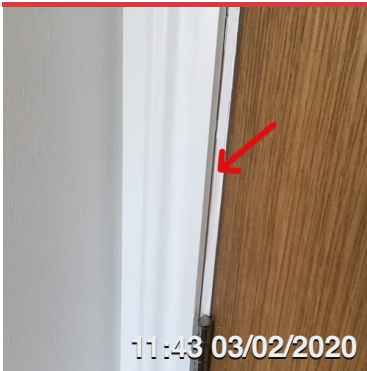
LOCATION 102 BEDROOM 1

The left hand en suite architrave needs caulking.

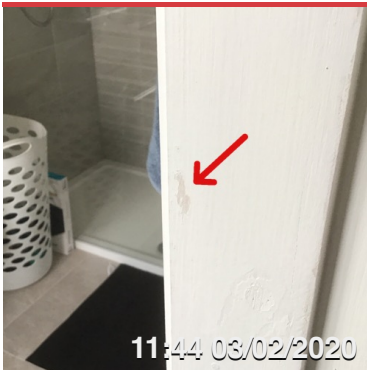
LOCATION 103 EN SUITE

The door casing needs touching up in several places.

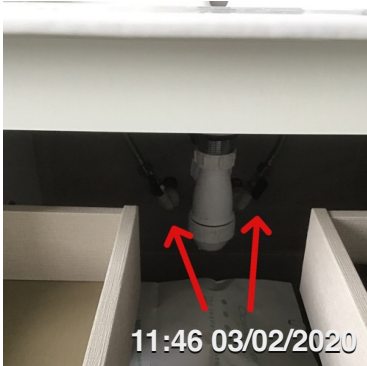
LOCATION 105 EN SUITE

The pipes need grouting in the vanity unit.

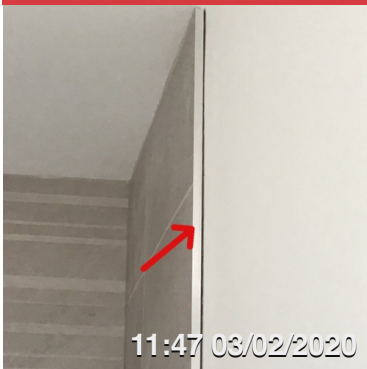
LOCATION 106 EN SUITE

The tile trim needs caulking.

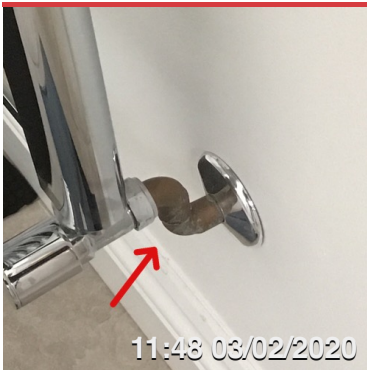
LOCATION 107 EN SUITE

The radiator pipes need painting.

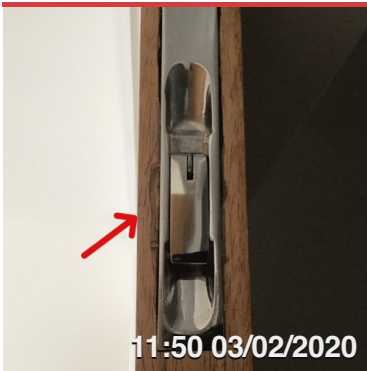
LOCATION 110 CYLINDER CUPBOARD

The door needs filling where the bolt has been poorly cut out.

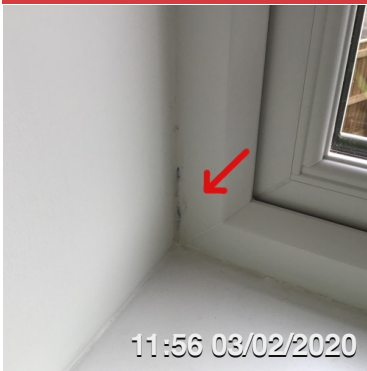
LOCATION 113 BEDROOM 3

The plastic protection needs removing from the window frame and re caulking.

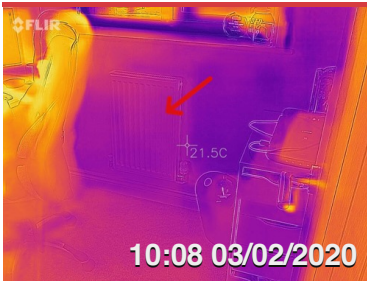
LOCATION 114 BEDROOM 5

The radiator is not getting hot and could need balancing or bleeding.

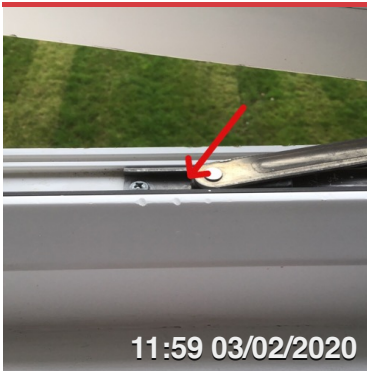
LOCATION 115 BEDROOM 4

The top of the window frame is damaged where materials have been brought in.

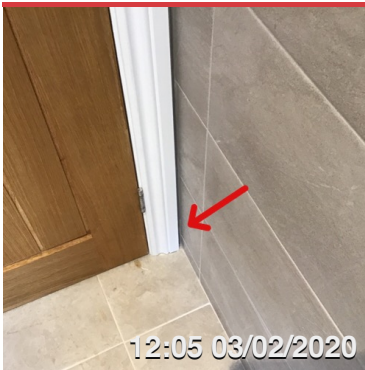
LOCATION 118 BATHROOM

A small piece of skirting board needs fitting between the architrave and tile.

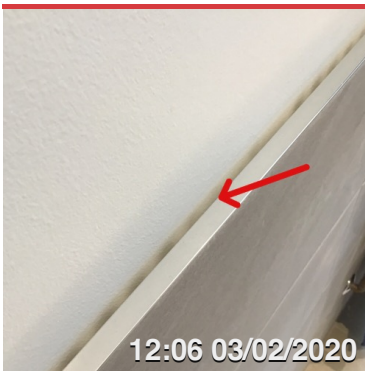
LOCATION 119 BATHROOM

The gap to the top of the tile trim needs filling.

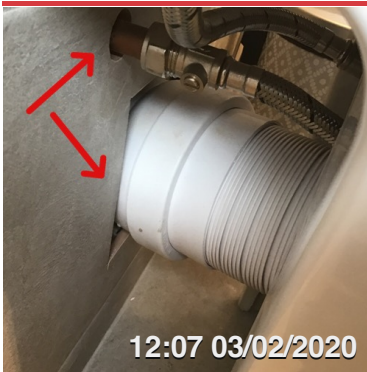
LOCATION 121 BATHROOM

The tilling needs grouting behind the toilet.

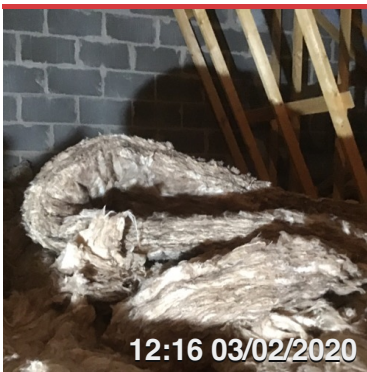
LOCATION 123 LOFT

The loft insulation is missing.
